LPC# 1210500002 Marion County
Sandoval Zinc Co. - Sandoval
ILD 053 980 454
F/HRS

Expanded Site Inspection

Sandoval Zinc Company
Box 263 Smelter Road Highway 51, Sandoval, Illinois
ILD 053 980 454

April 5, 2010

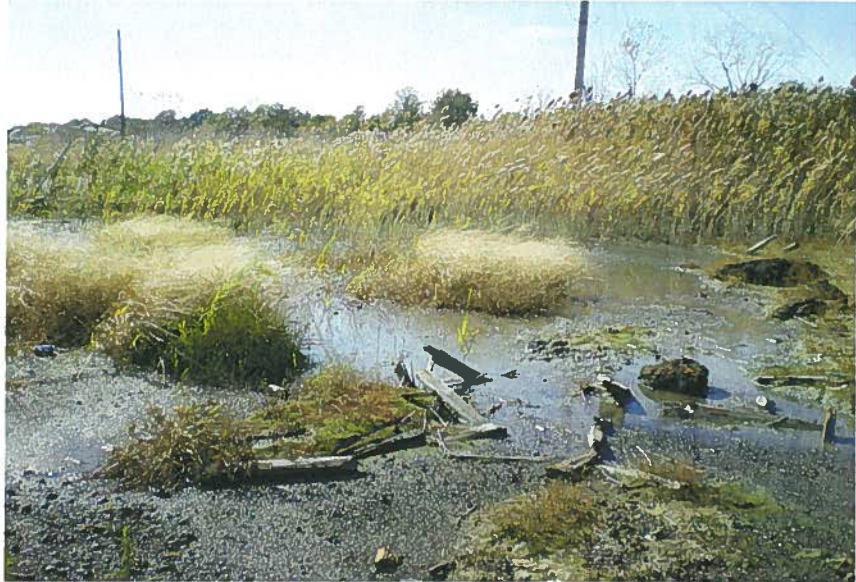
Picture taken of the drainage of water from the site to the southwest corner of the site.

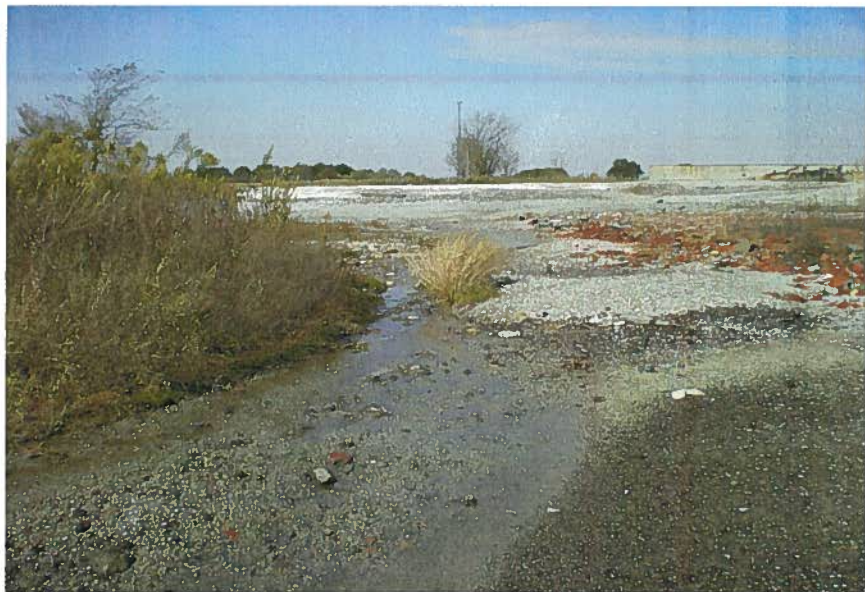
Picture taken of the surface water draining south off of the site.

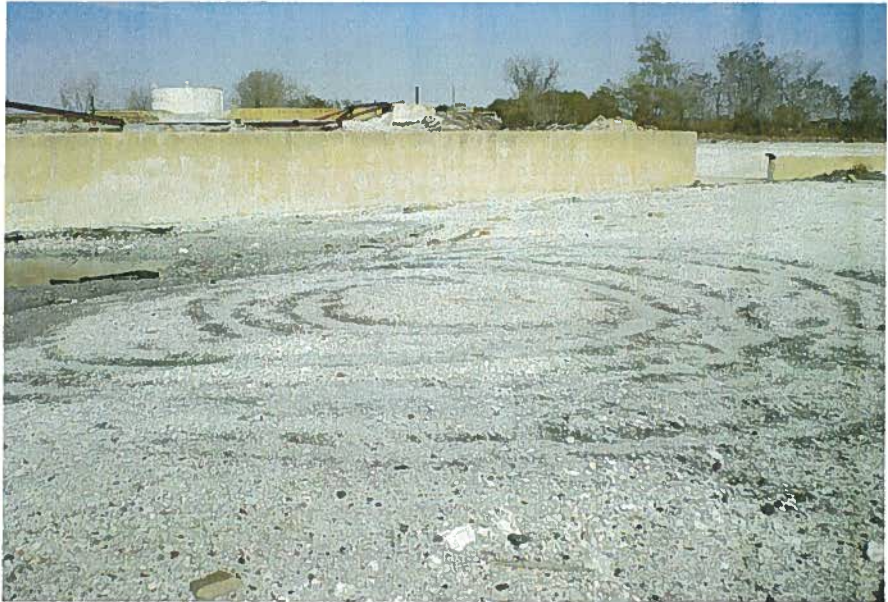
Picture was taken to identify human trespassing at the site. Photo depicts four-wheeler tracks at the site in a radial pattern indicating that donuts were being conducted at the site and in all probability stirring up contaminated dust.

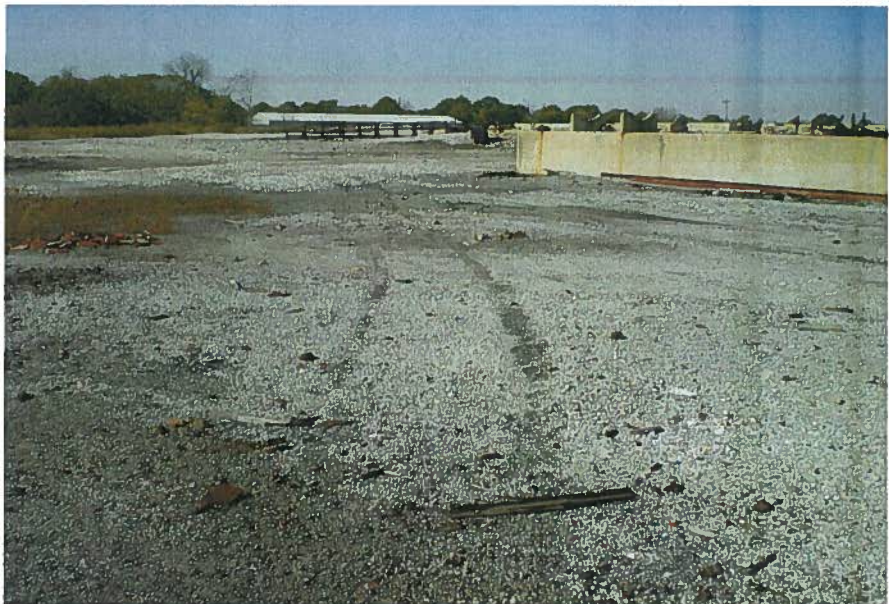
Picture taken of vehicle tracks through the property. Evidence of trespassing activity.

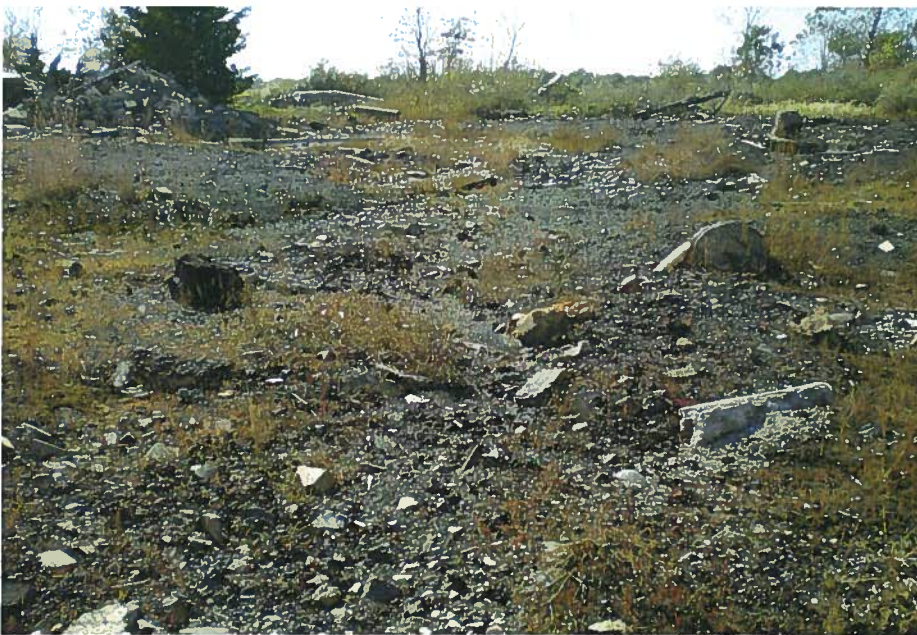
Photo taken of the drainage pathway from the site draining to the east towards the fence and wetlands.

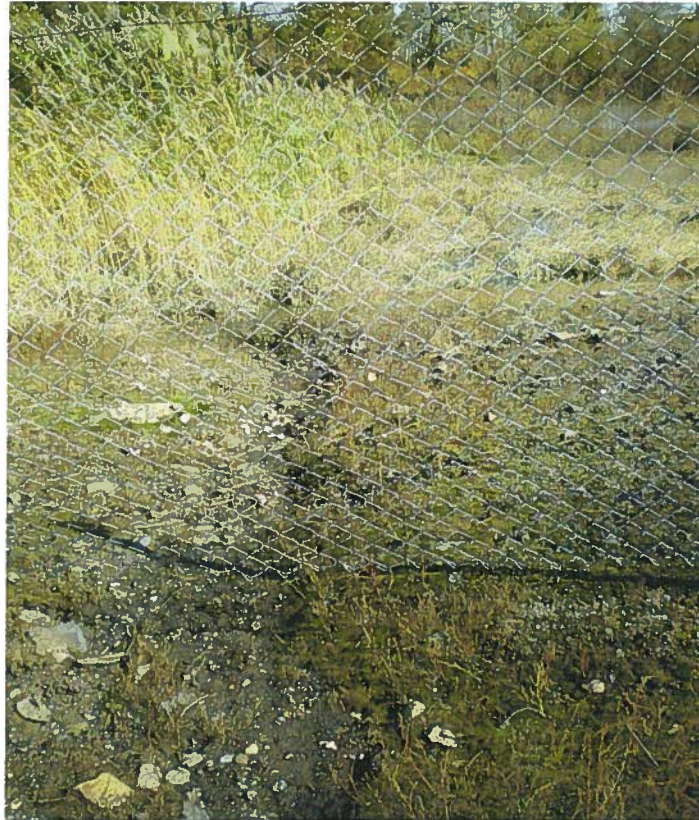
This photo was taken to continue the drainage pathway from the site towards the wetlands and pond located east of the fenced portion of the site.

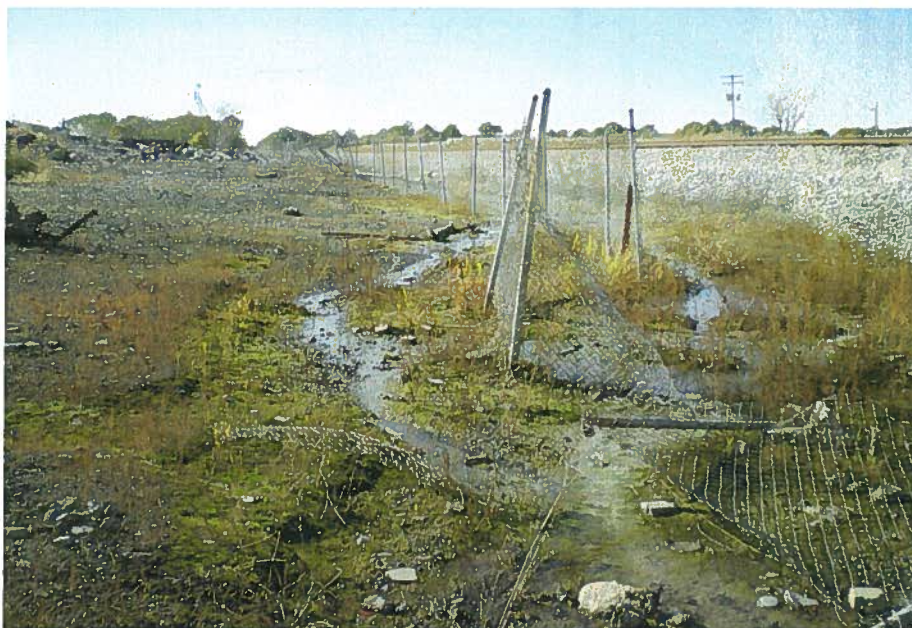
This photo was taken of the surface water drainage from the north side of the site which flows east along the railroad tracks to the wetlands located at the east end of the fenced property.

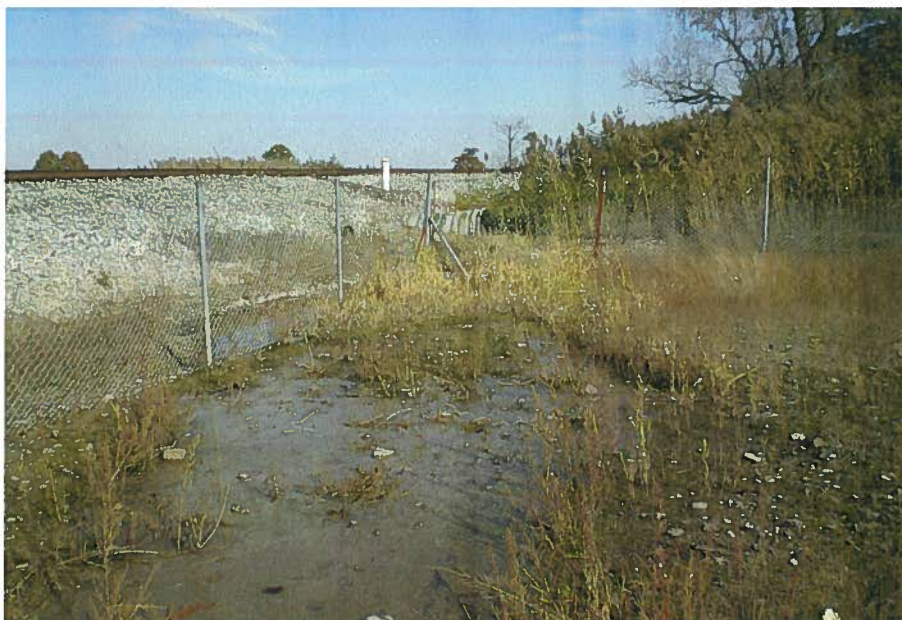
This photo is a continuation of the surface water drainage from the north side of the site. This photo depicts the water from the site flowing to the wetlands located east of the fenced portion of the property.

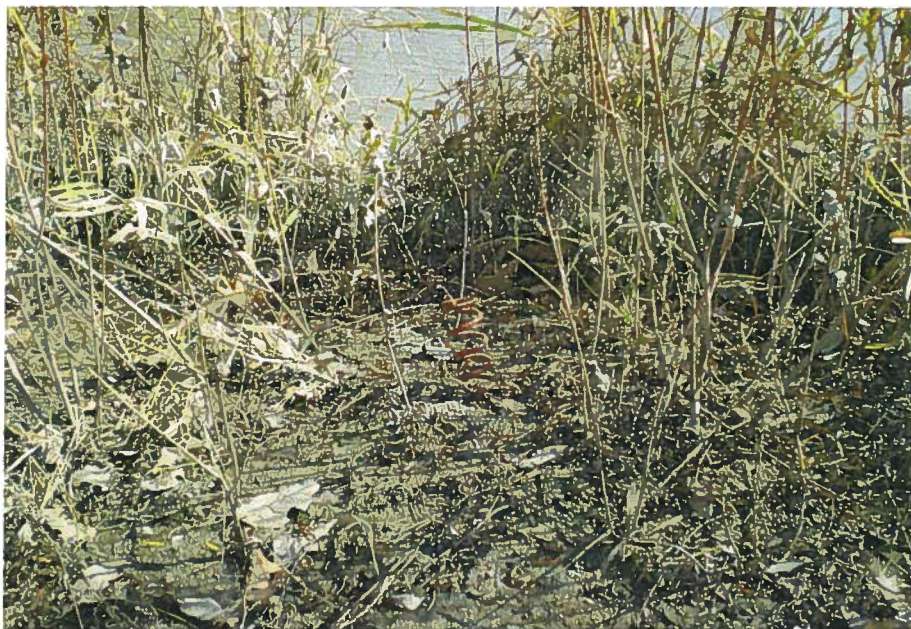
Photo documentation of fishing that has occurred at the pond located east of the site. Notice the pole holder (red in color) which was found along the bank of the pond. This evidence suggests that residents in the area are utilizing the pond for fishing purposes.

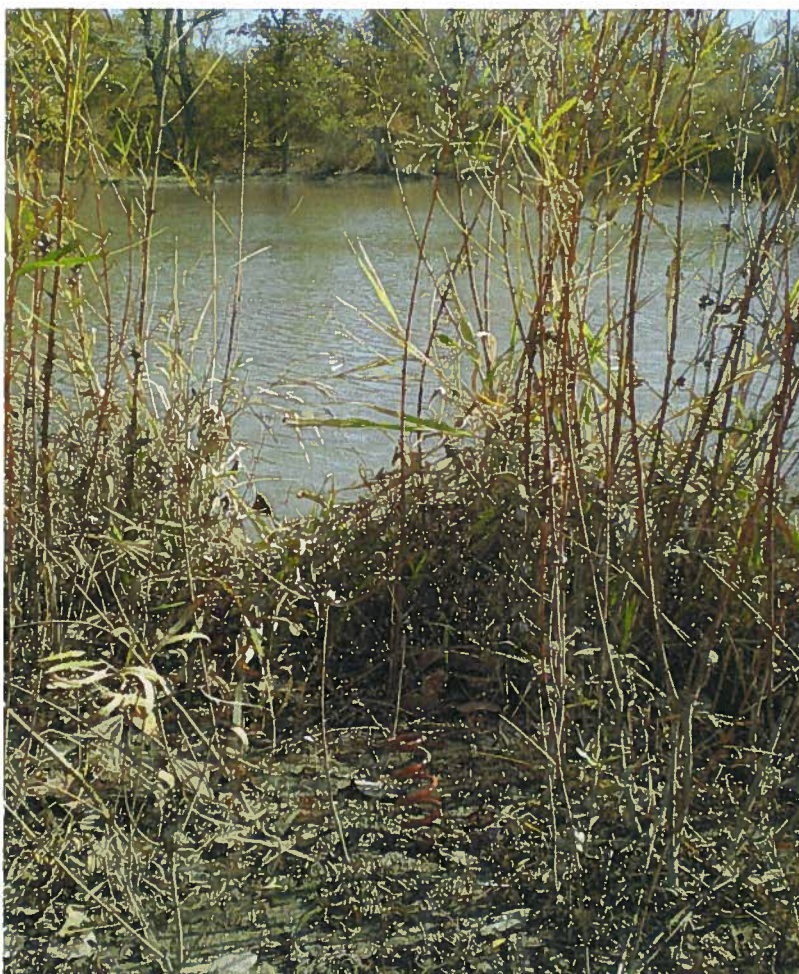
Photo documentation of fishing that has occurred at the pond located east of the site. Notice the pole holder (red in color) which was found along the bank of the pond. This evidence suggests that residents in the area are utilizing the pond for fishing purposes.
